No. : 04 -2007

**Subject : EXU 16 – 0140, EXU 18 – 0141, EXU 20 - 0142
„BOOMERANG - Side Protection “**

We have received several complaints about damaged or torn off motor covers on EXU – trucks and we have decided to set up in series a metallic protection.

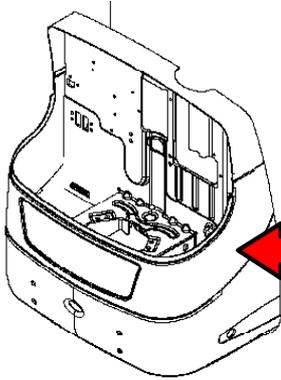
Basic version of the previous chassis – without any side protection :

Original version **without**
„Boomerang“

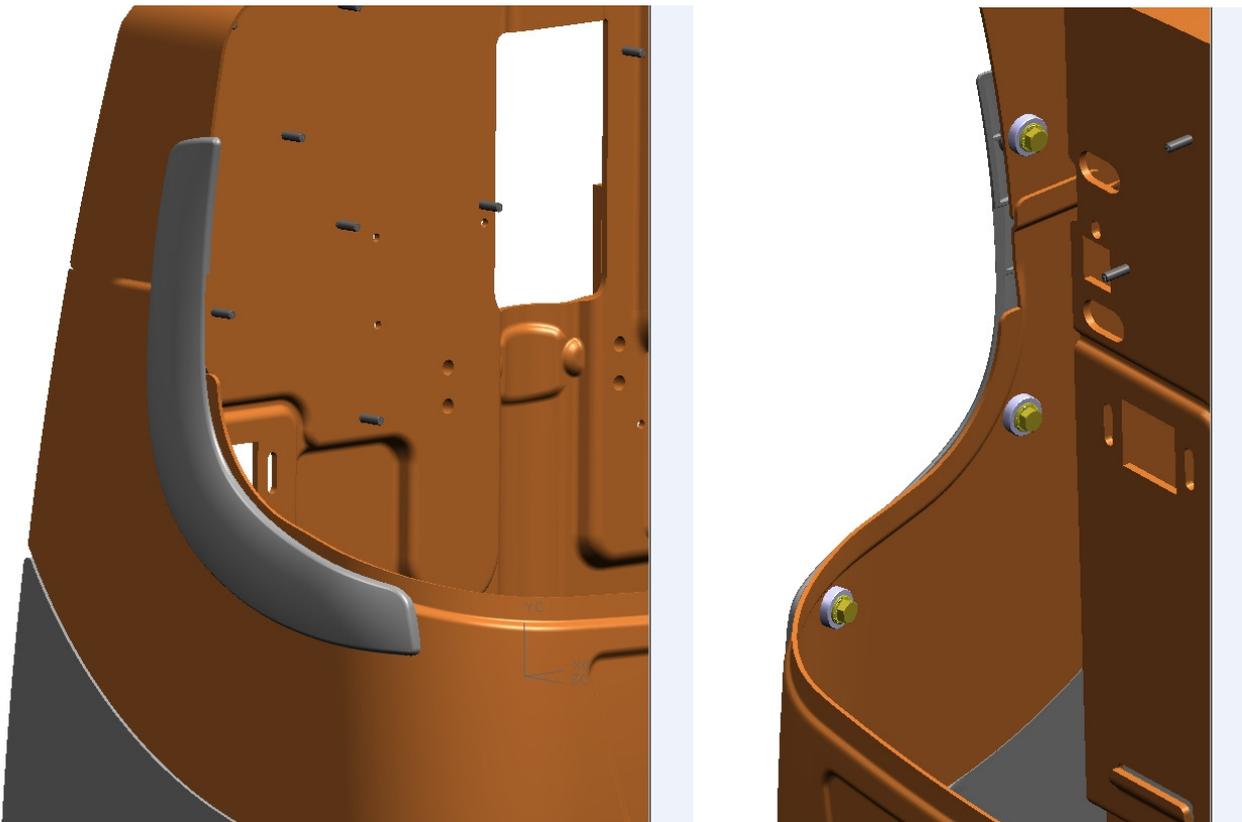
The interest of this side protection is to prevent the motor cover from being damaged or torn off when loading or unloading different products.

New version :

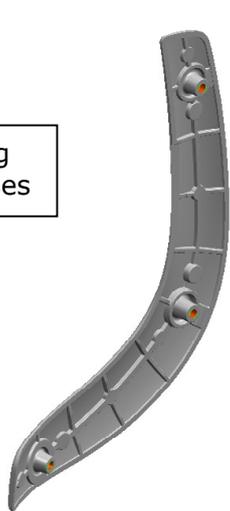
Inside Boomerang
with 3 fixing bosses

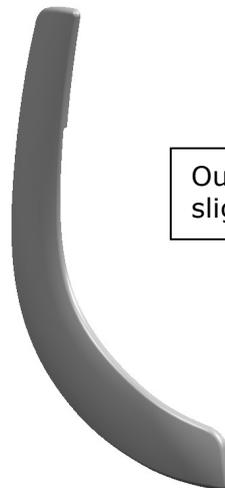
Outside Boomerang
slightly curved

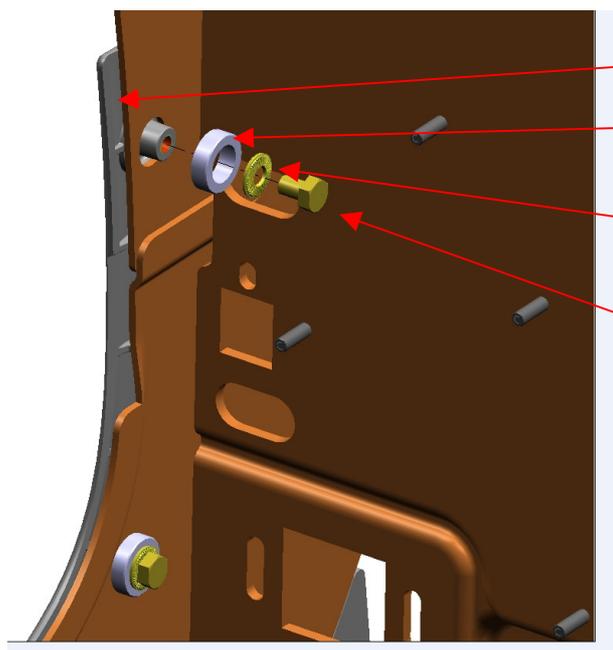
- A) Boomerang**
- B) Big washer**
- C) Thin washer**
- D) Screw**

Mounting of the two Boomerangs in After-Sales Service :

Bore 3 holes and add the parts ordered (see below) :

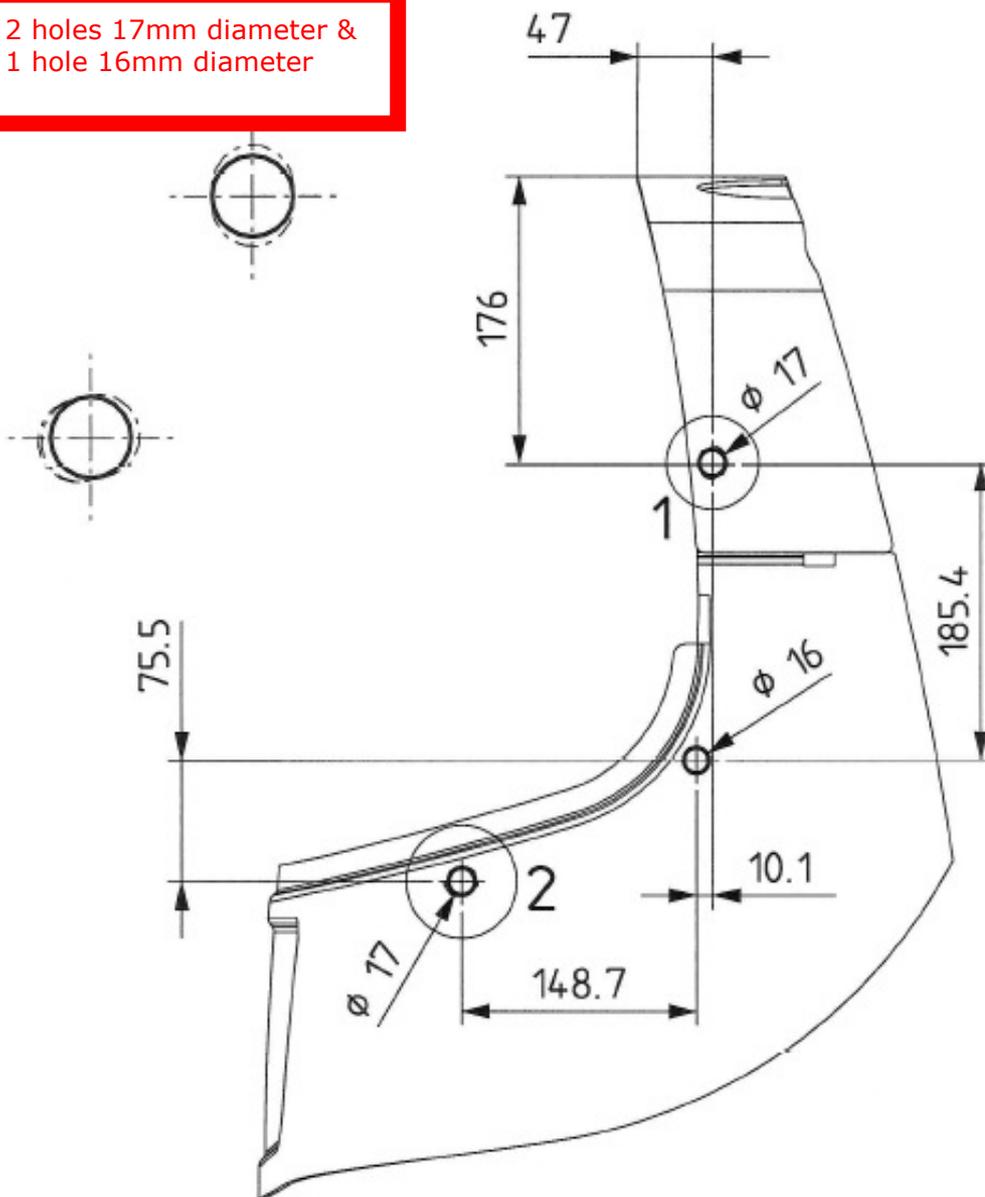
2 holes 17mm diameter &
1 hole 16mm diameter

In the following I joint the mounting plan :
